Specialist Report:
Ohlanga River and Estuary Impact Assessment
for the proposed Cornubia Mixed-use Development
ver 1.0

Tongaat Hulett Developments

26th October 2009

Ohlangu River and Estuary Impact Assessment for the proposed Cornubia Mixed-use Development

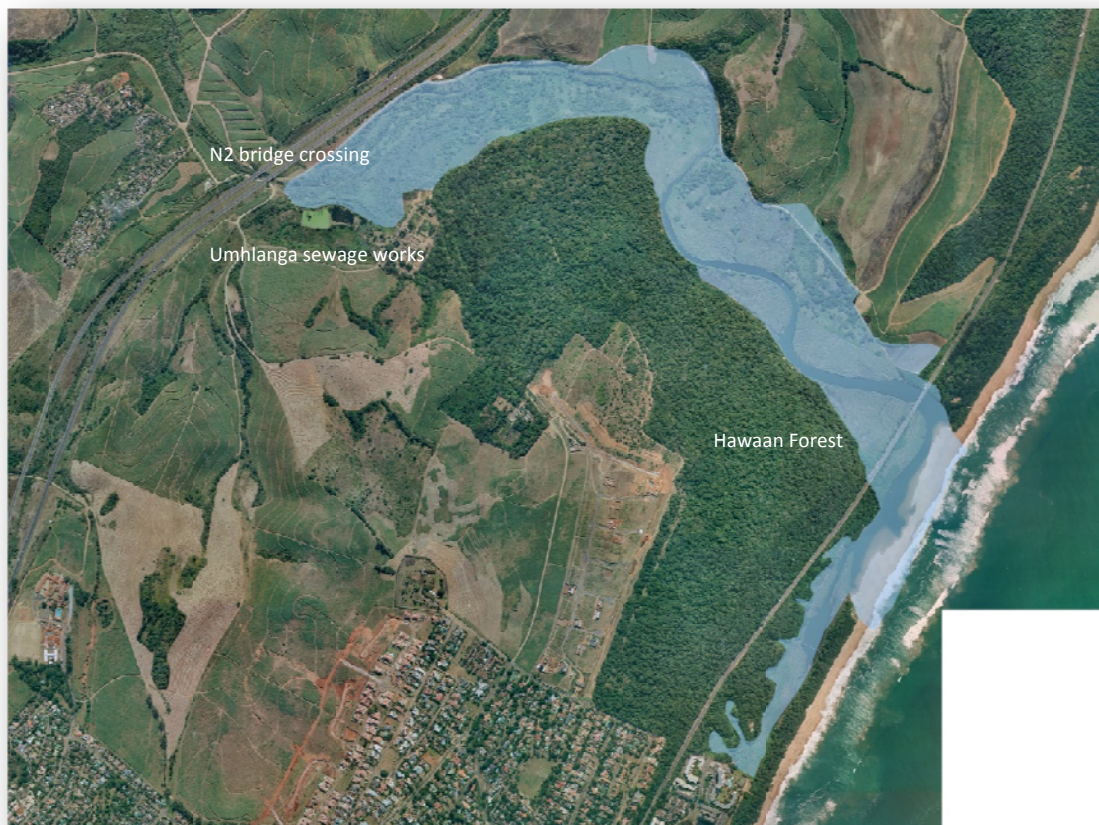
Figure 1: Ohlanga estuary with core estuarine area (blue shading) and key features.

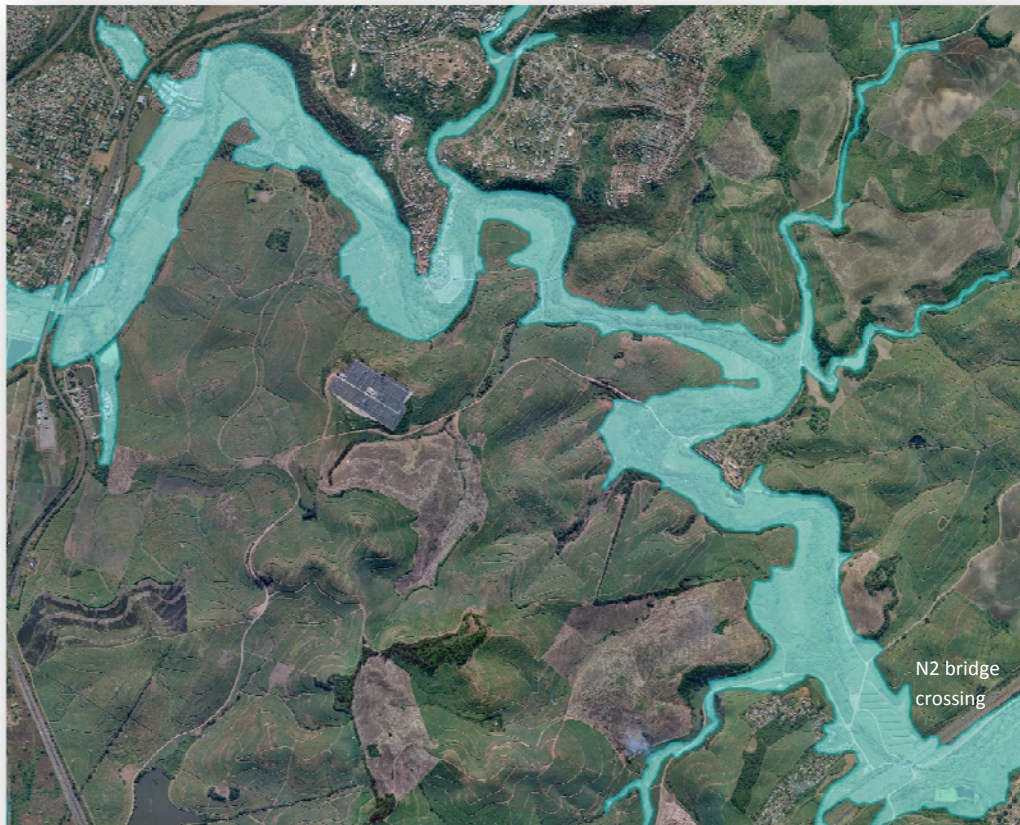
Figure 2: Section of the Ohlanga river adjacent to the Cornubia development with 100 year floodline and riverine area indicated

Estimates of the oHlanga catchment area range from 85 to 196 km² Begg (1978) but Perry (1989) and Cooper (1989) give a figure of 118 and Perissinotto *et al.* (2004) 80 km². River length (Perry 1989) is 28 km. The estuarine boundaries based on the position of the 5 m amsl contour are shown in Figure 1. The river boundaries for the river section within the limits of the proposed development are demarcated as the 1:100 yr floodline (Figure 2).

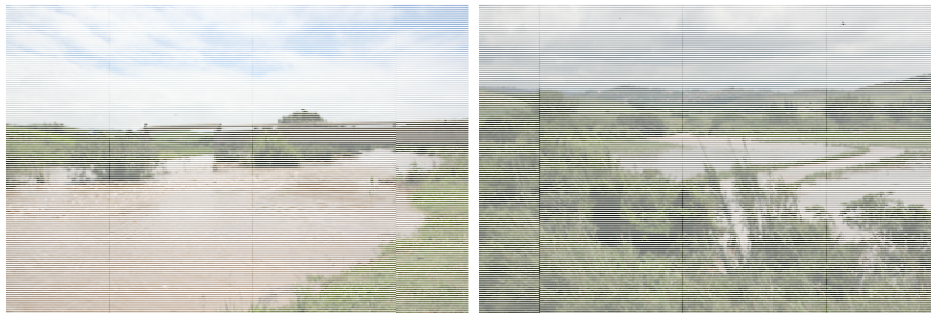
Ohlanga estuary west of the N2 during a small localised flood event – note the inundation of inappropriately placed roads and cane fields.

Mean Annual Runoff estimates range from 19.7 to $29.5 \times 10^6 \text{m}^3$ with an intermediate of $26 \times 10^6 \text{m}^3$ (Cooper 1989) and a low of $12.6 \times 10^6 \text{m}^3$ (Perissinotto *et al.* 2004). There does not appear to be a good record of flood events but in January 1953, following 45 cm of rain overnight, water levels allegedly rose to 2.4 m higher than the normal high water mark. A small localised flood observed during February 2008 partly due to the bottleneck effect of the N2 bridge design resulted in flooding of sugar cane, roads and remaining wetland areas inland of the N2. The water was extremely turbid (See photographs below) indicating a high silt load.

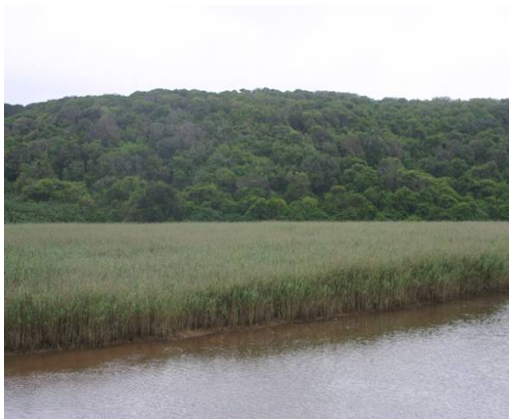
Phragmites sp. reeds lining the main river channel with the Hawaan forest as backdrop

The current survey of the oHlanga suggests that not much change has occurred to the riparian and floodplain vegetation of the estuary since 1937. The historical pictures show a river meandering through broad areas of reed swamp with coastal forest on the southern bank. The integrity and conservation status of the adjacent coastal forest and the extent of the reed swamps make this a unique system in the KZN context. Invasive alien vegetation remains a problem, but this is mostly associated with man-made structures and disturbance caused by construction and maintenance.

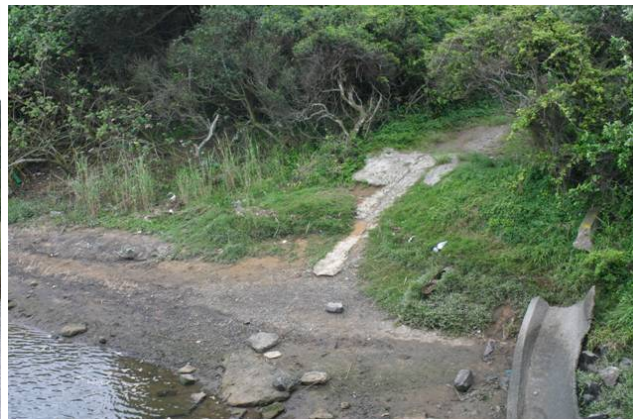
Disturbance of the riparian zone

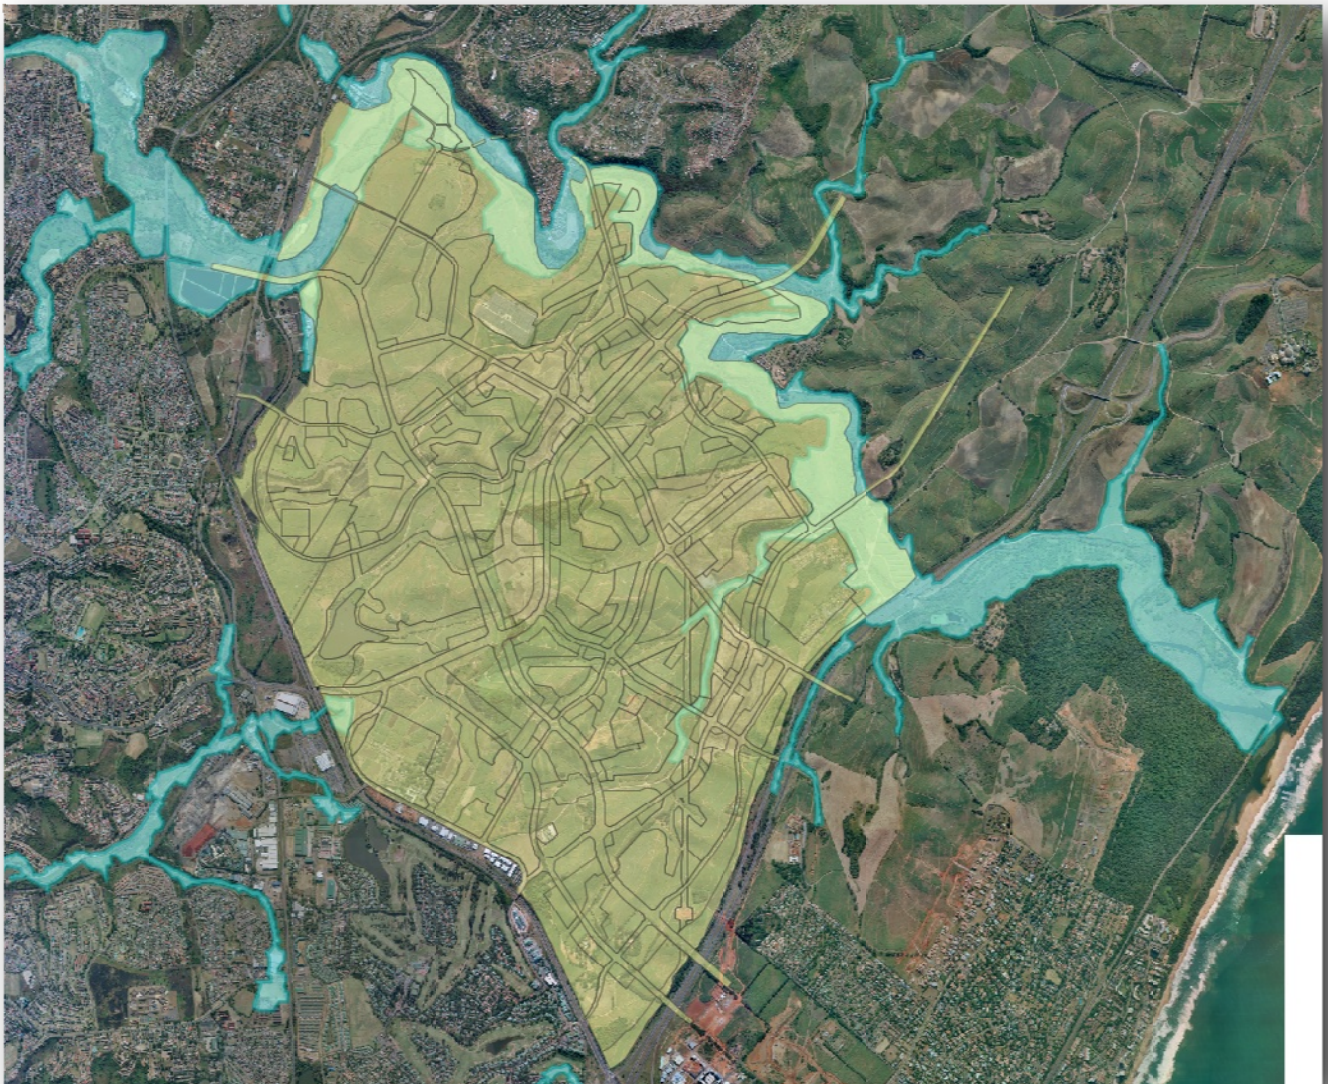
Figure 3: Cornubia Framework Plan (yellow) with oHlanga river and estuary boundaries (blue). Areas of overlap of Cornubia and ecological boundaries indicated in green

The Cornubia development is bounded in the north by the oHlanga river while the north bank and surrounds is largely under cane with some urbanisation upstream east of the R102 (Figure 3). The project proposes a mixed use area with high density residential to light industrial developments. The available plan (September 2009) does indicate a complex of open spaces covering 362 ha, or *ca.* 28% of the total area, which has the potential to provide possibly more valuable ecological habitat than exists at present under cane. This will, however, require substantial control of building activities, invasive alien plants and run-off during the construction and life of the development. Concrete lined drainage canals might speed run-off but this would be to the detriment of both the “green spaces” and the receiving river and estuary.

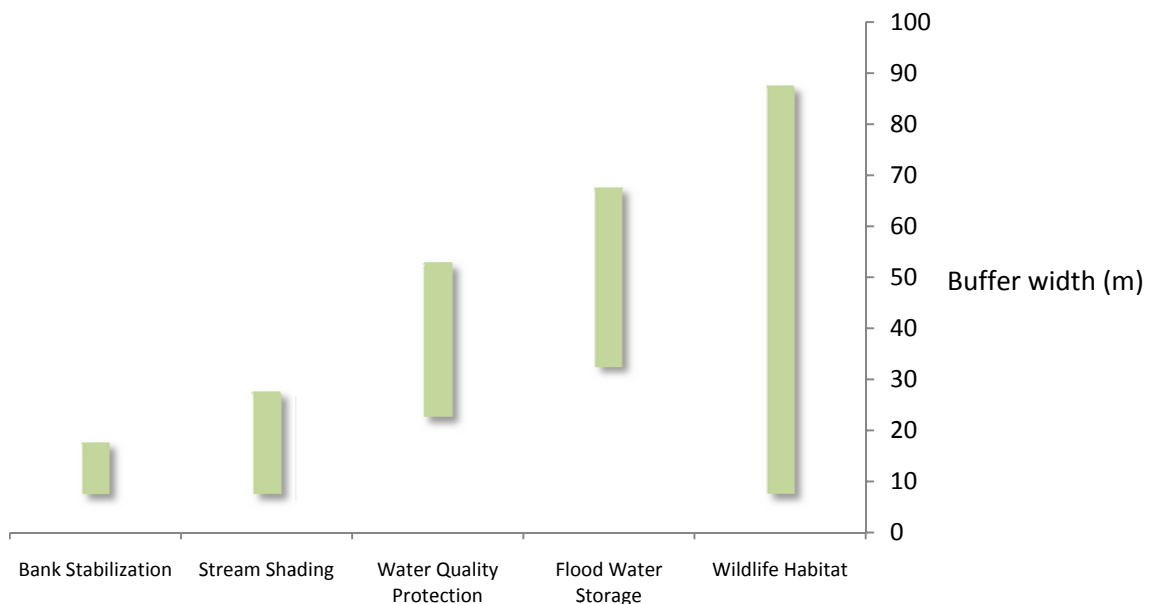
Figure 4: Aquatic buffer functions associated with buffer width (Adapted from USDA Natural Resources Conservation Service. Where the Land and Water Meet: A Guide for Protection and Restoration of Riparian Areas First Edition. USDA NRCS, September 2003)

A substantial body of research exists that correlates aquatic buffer width with ecological function or value (Figure 4). Establishment of buffers must balance these functions with the constraints found in urban and suburban settings. Buffer widths can begin with a minimum width based on certain baseline criteria and then be increased (and perhaps decreased) based on site-specific considerations and the goals and objectives of the buffer, e.g., protection of water quality, habitat, etc. Recommended minimum riparian buffers are provided in Table 1.
