Rehabilitation of the Ritespruit Dam Wall in Ventersdorp, North West Province – Wetland Delineation Report

Department of Water and Sanitation

October 2015

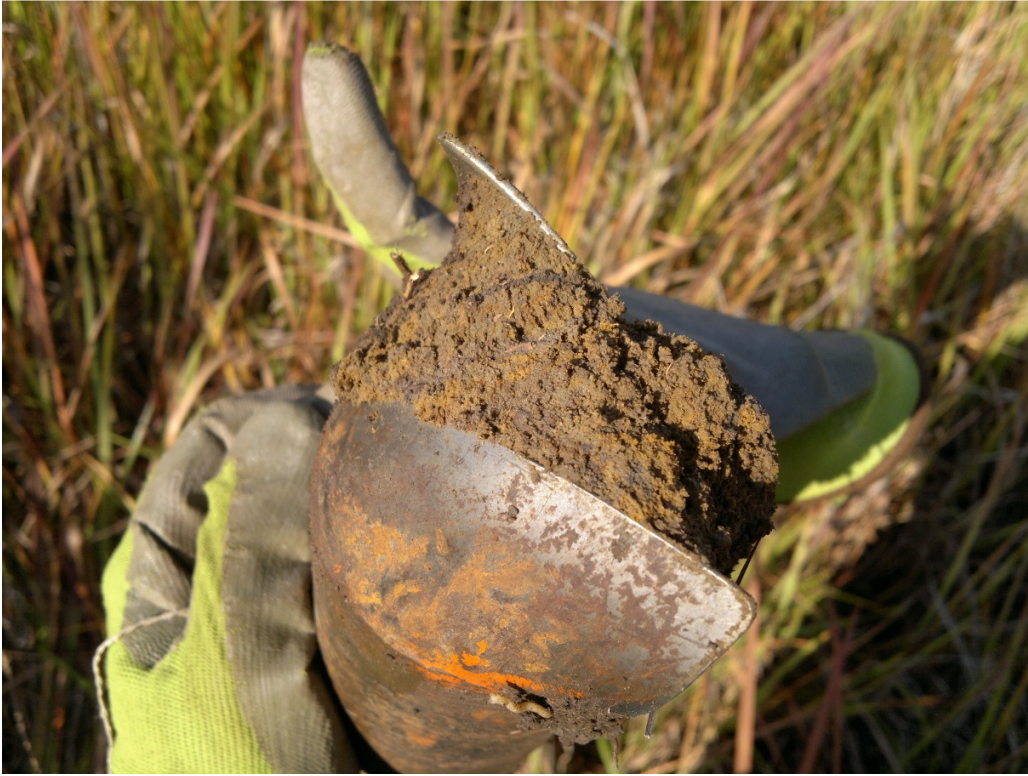
Figure 1 – Example of Soils from a Soft Plinthic B Horizon

The predominant soil form encountered within the area of hydrophytic vegetation was the Westleigh Soil Form (Orthic A →Soft Plinthic B), with an Avalon Soil form (Orthic A→Yellow-brown Apedal B→Soft Plinthic B) encountered on the margins of the area of hydrophytic vegetation at one of the sample points. Both of these soil forms are classified as wetland soil forms (DWAF, 2005). Soils sampled within the area of hydrophytic vegetation downstream of the spring located to the north of the canal (i.e. located further downslope towards the Rietspruit valley bottom) also displayed soft plinthic characteristics, with the occurrence of Westleigh Soil Forms at the two sample locations investigated north of the canal. Certain of the soil samples in the area of hydrophytic vegetation to the south of the canal indicated that the soft plinthic B horizon was underlain by a hard plinthic B horizon, with the presence of an indurated plinthic layer at depth here appearing to correspond to the outcropping of the hard plinthic layer to the north (downslope) as discussed below. In the soil samples to the north of the canal in which a Westleigh Soil form was encountered, the soft plinthic layer morphed into non-diagnostic gleyed material (dark grey gleyed clays) that typically occurs with soft plinthic B horizons. The presence of these two soil forms (and predominance of soft plinthic B horizons) is confirmation that the area to the north and south of the canal is a wetland with the occurrence of hydromorphic soils that formed under natural conditions.

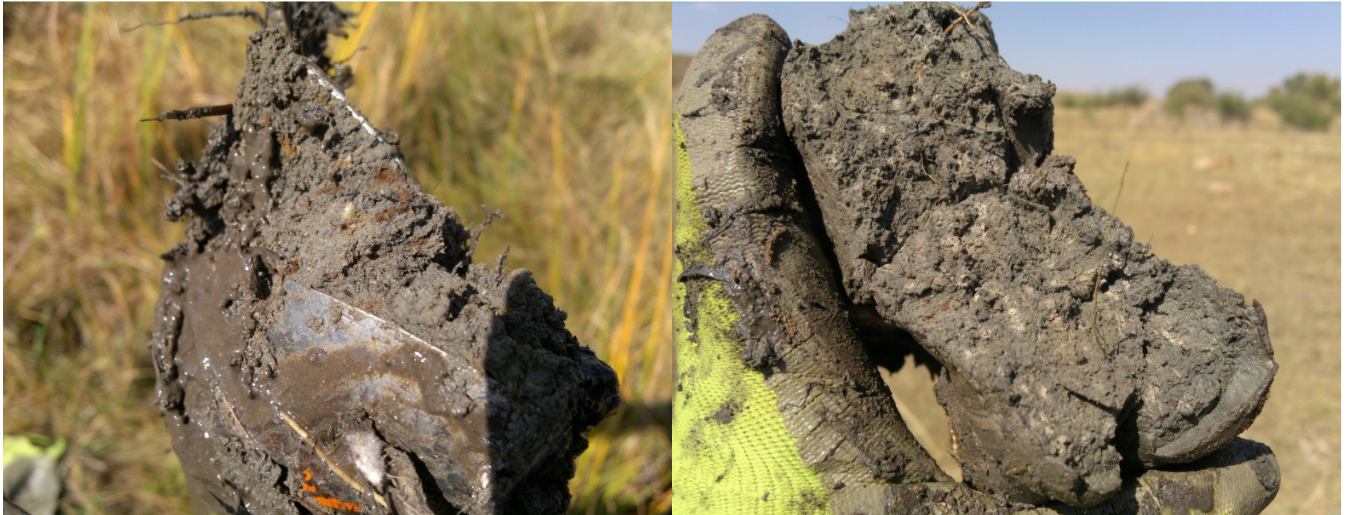
Figure 3 – Soils from a G Horizon at the spring located to the north of the canal

The soils were also sampled in a localised area of *Typha capensis* rushes in which groundwater discharge was occurring (i.e. a spring – refer to Figure 9) located to the north of (downslope of) the canal; these soils displayed different characteristics to the rest of the soil samples on the site. A Katspruit Soil Form (Orthic A→G) was encountered at the spring. This soil form is also a wetland soil form and is typically found in wetland areas typified by permanent saturation levels. The G horizon forms in conditions of extended or permanent saturation, resulting in the gleying of soils and the net accumulation of colloidal matter. The presence of the Katspruit soil form in the spring is very strongly indicative that this is a naturally-occurring spring which caused by the discharge of groundwater, being unrelated to any seepage from the dam (refer to section 3.1.3) below.

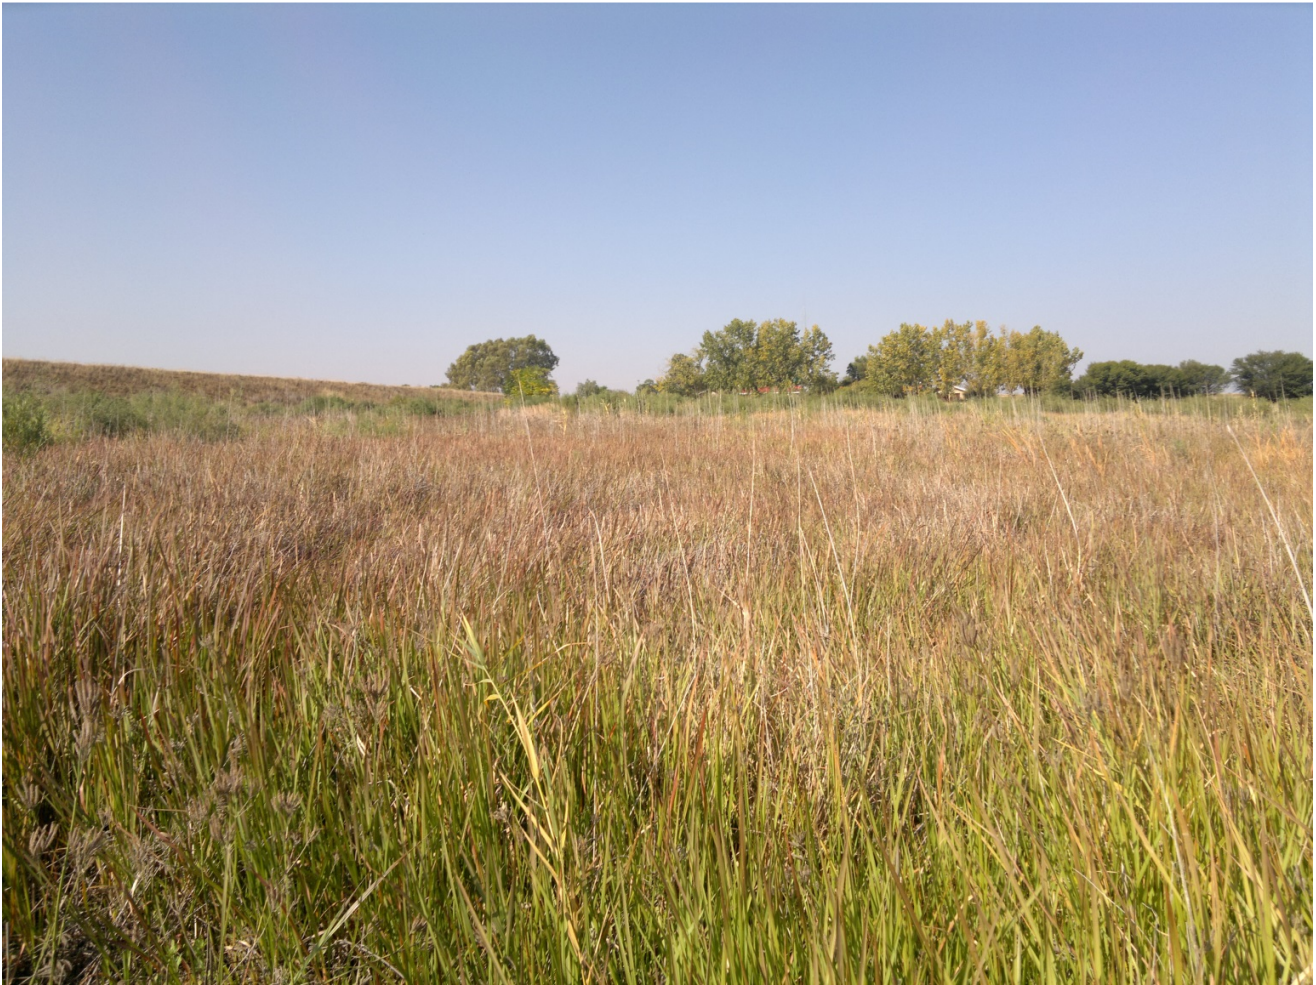
Figure 4 – Tall, dense stand of *Imperata cylindrica* to the south of the canal

The predominant species within the area of hydrophytic vegetation to the south of the canal is the grass species *Imperata cylindrica*. This species is a facultative hydrophyte (i.e. it occurs both within and outside of wetlands – Kotze and Marneweck, 1999), however that designation is likely to apply more to the mesic eastern seaboard of South Africa which experiences high levels of mean annual precipitation. In the context of the drier western interior of South Africa in which the study site is located (the general area has a MAP of 580mm – Mucina and Rutherford, 2006), this species is more likely to be an obligate hydrophyte, only occurring within wetlands. This species formed dense, tall stands, with the area in which the hydrophytes are located to the south of the canal not appearing to be grazed by livestock.

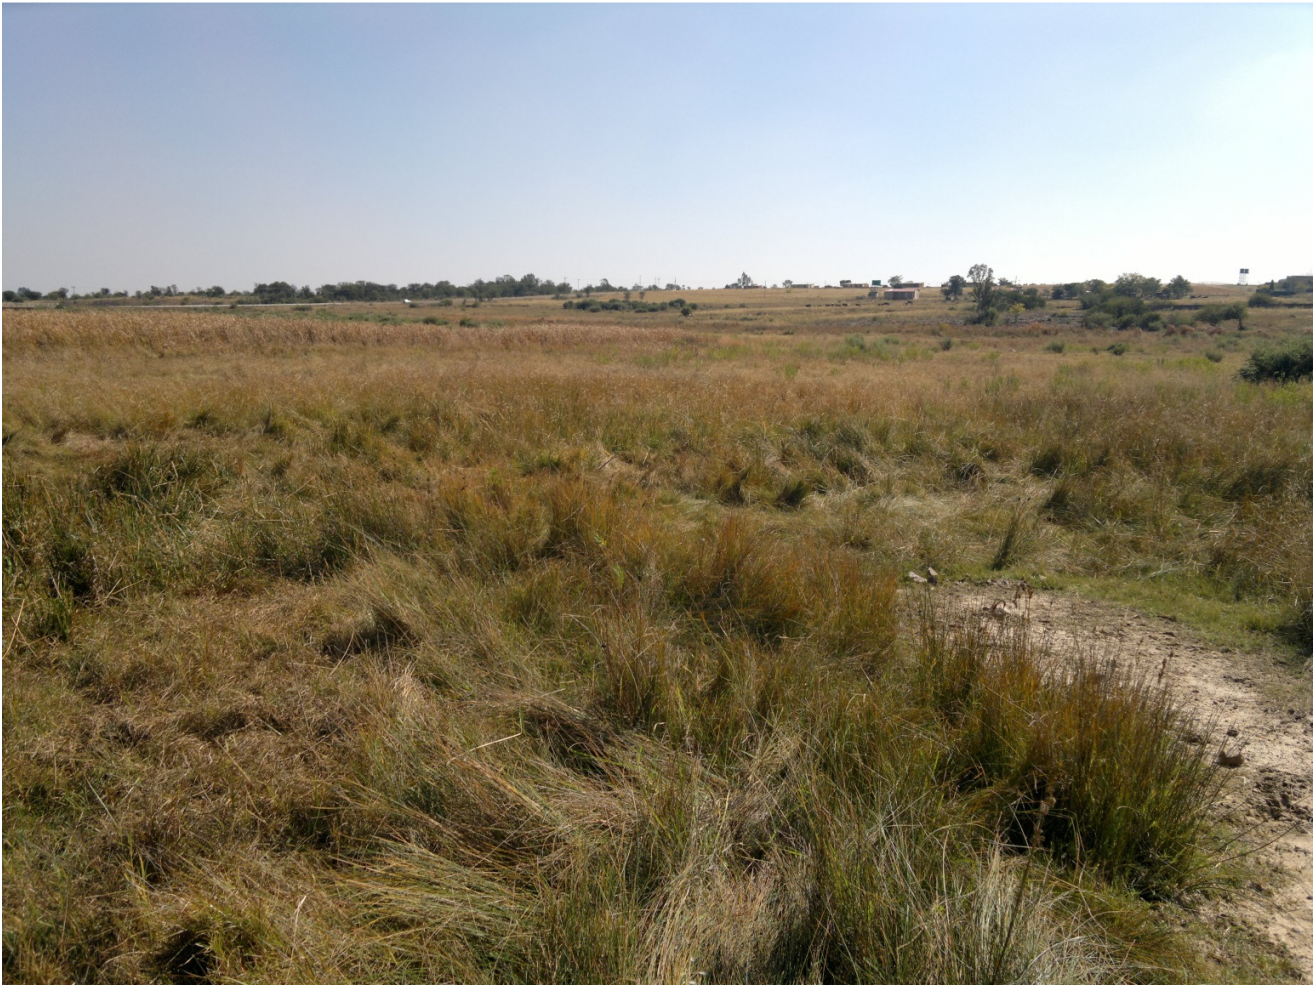
Figure 5 – The wetland downstream of the spring feeding down into the valley bottom of the Riet Spruit

To the north of the canal, other areas of hydrophytic vegetation were sampled. The area of active groundwater seepage (natural spring) was characterised by the presence of a dense stand of *Typha capensis*, an obligate wetland species. This species was also found along the artificial channel emanating from the canal artificial (see section 3.1.3 below) and within the saturated area into which this channel and the natural spring feed. In the vicinity of the spring and downstream of the spring other typical hydrophytes were encountered including the grass species *Andropogon eucomis*, sedge species such as *Juncus exsertus*, *Schoenoplectus corymbosus* and other hydrophytic herbs such as *Ranunculus multifidus*, *Berula erecta* and *Marsilea macrocarpa*. The predominance of these hydrophytes is a strong confirmatory factor of the presence of wetland habitat on the site. Although hydrophytes can colonise an area of artificial saturation, this vegetative assemblage along with the presence of hydric soils is confirmatory of the presence of natural wetland habitat.

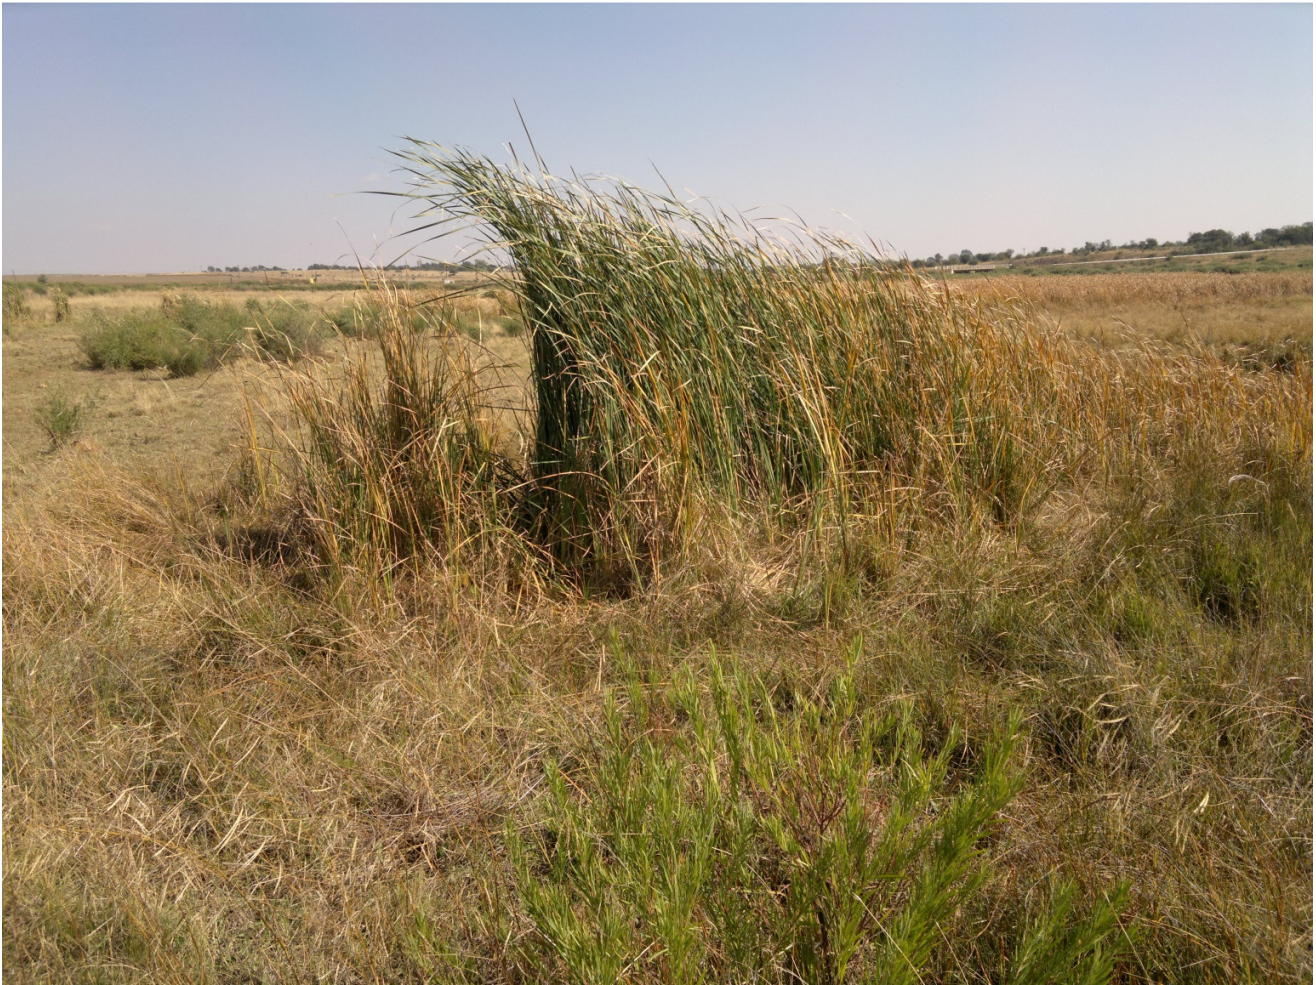
Figure 6 – The natural spring located to the north of the canal

It is important to note that certain of the hydrological inputs to the wetland area to the north of the canal are artificial. As mentioned above an artificial channel is located to the west of the spring. Analysis on the site revealed that this channel which is lined with *Typha capensis* rushes is directly linked to a sluice gate in the canal. Although the sluice gate was closed, small volumes of water were visibly draining from the canal into the channel. This artificial source of water is feeding the downstream wetland and from the site analysis has effectively widened the area of wetland that would naturally be present due to outflow from the spring to the east, as the artificial channel feeds into that wetland.

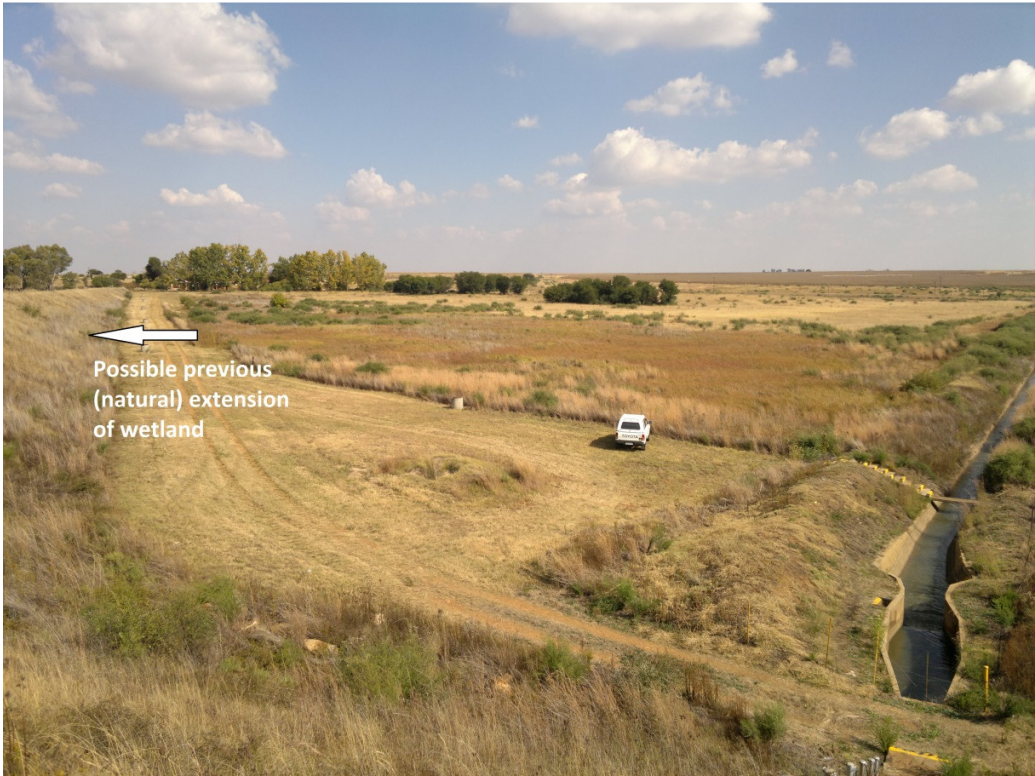
Figure 7 – The seep wetland with no channelled outflow to the south of the canal

Under the Ollis *et al* (2013) categorisation, the sub-categorisation of seeps relates to the nature of the outflow, with seeps either having channelled or without channelled outflow. It is hypothesised that *both sub-categories of seep wetlands naturally* occur on the site. The upper part of the seep wetland (i.e. the portion to the south of the canal) is likely to have naturally had no channelled outflow. The sub-surface hydrological inputs in this upper part of the wetland appear to be naturally related to the presence of a rising and falling groundwater table (possibly due to a perched aquifer), with no natural outflow or discharge of water present (in spite of the transformative presence of the canal). The presence of the natural spring and associated downstream wetland which feeds into the valley bottom wetland / stream falls into the second sub-category of seep. Although no distinct channel exists, this lower part of the seep wetland is hydrologically connected to the wider drainage network via the wetland that feeds into the Riet Spruit downstream of the dam wall.

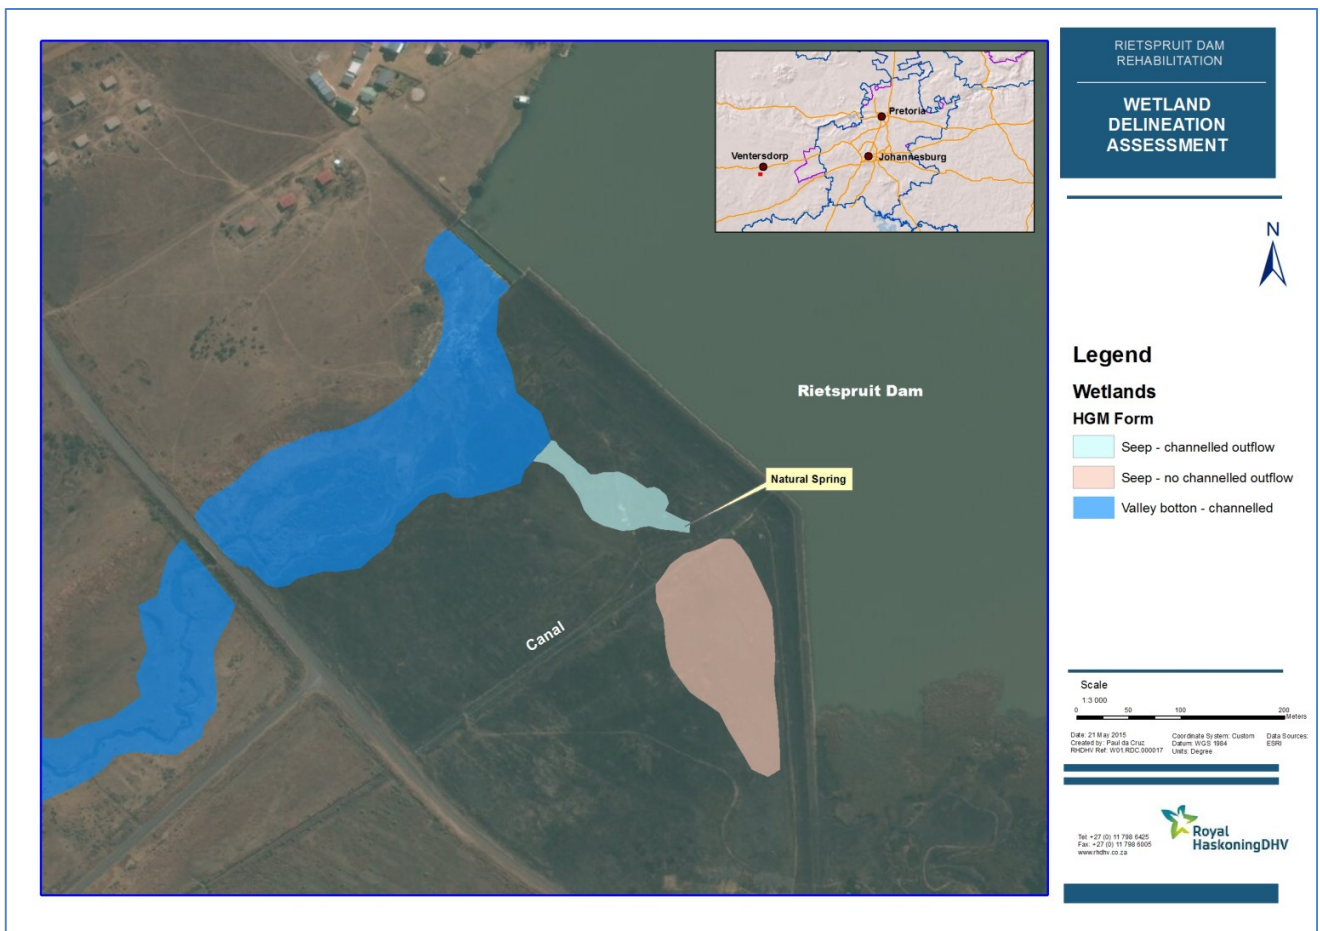
Figure 9 – Location of Wetlands downstream of the Rietspruit Dam Wall

The current boundaries of the wetland are indicated in Figure 9 below. The boundaries on the eastern side of the wetland stop at the edge of the access track located immediately adjacent to the toe end of the dam wall. This access track although grassed consists of fill material (imported crushed rock). It is thus highly that part of the eastern part of the wetland has been transformed by the presence of the track as well as by the dam wall.

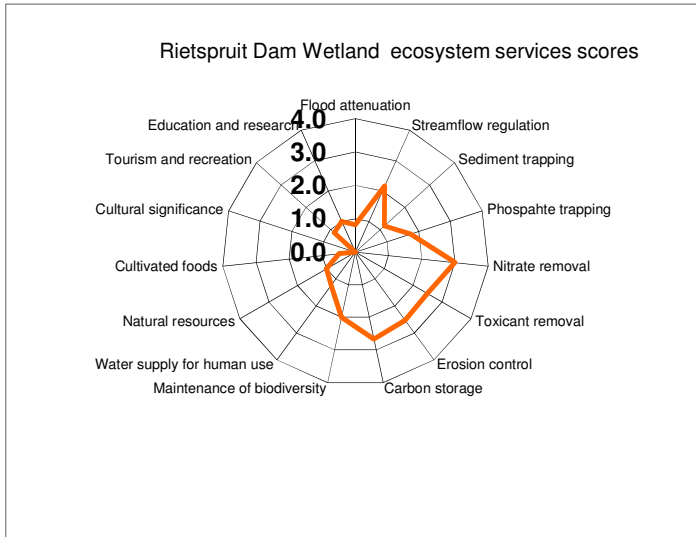
The graph below indicates the outcomes of the wetland functionality assessment.

No ecosystem services were assessed to be performed to a high degree. The following ecosystem services were however assessed to be performed to a moderately degree:

- Nitrate removal
- Toxicant removal
- Erosion control
- Carbon storage
